## Berneslai Homes Fire Risk Assessment

Berneslai Homes-Albion House Block 01 - 56 -  
 UNION STREET: S70 1JT,- UPRN: BJ12001B /  
 115784 / QA Approved / Paul Doodson

Berneslai Homes-Albion  
 House Block 01 - 56 - UNION  
 STREET: S70 1JT,- UPRN:  
 BJ12001B, Fire Risk  
 Assessments, Berneslai  
 Homes

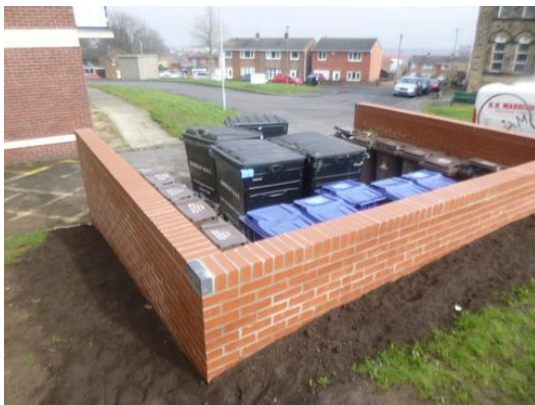
Photo 3

The bin chute was still available within the ground floor corridor and not separated by compartmentation. The image shown is the new bin location.

The bin chute was located along the ground floor of the building and any fire would spread into this common area placing relevant persons at risk of harm. Remove the bin chute on the ground floor as per floors one to six and inform residents that they should take their rubbish to the new bin compound outside the property.

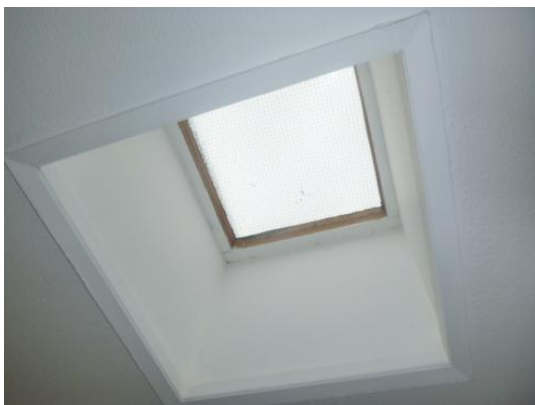
Photo 5

The ventilation at the head of the staircases had been enclosed and any smoke in this area would not be able to naturally vent as the small ventilation bricks were not suitable and this can place relevant persons at risk of harm.

The permanent ventilation at the head of the staircases have been enclosed and any smoke will not be able to be removed from this area placing relevant persons at risk of harm. Undertake a survey to ensure that there is adequate free space of 1 metre squared of ventilation within the staircases.

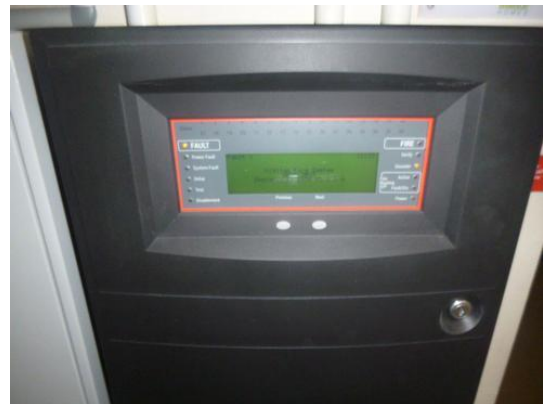
Photo 10

A common fire alarm to BS 5839 part 1 L2 standard incorporating automatic fire detection is installed within the common areas and the flats. With the exception of the issues identified within this Fire Risk Assessment, it was not identified that there are any serious breaches in the fire compartmentation where a common fire alarm would be a benefit as a compensatory feature. When the findings of this Fire Risk Assessment are remedied, the most appropriate fire strategy for these premises would be a stay-put policy and a communal fire alarm system conflicts with this principle. Purpose-built blocks of flats are not required or do not benefit from common fire detection.

A common alarm was fitted within all the common areas. Where the fire resistance meets with the benchmark standards (property compartmented in line with the building regulations 1991) and every flat entrance door is self-closing the common fire alarm system should be removed/disabled providing there are no doubts about the level of compartmentation between the flats and the common area.
