## Berneslai Homes Fire Risk Assessment

Berneslai Homes- Buckley House Block 1 - 55 -  
 UNION STREET: S70 1JS,- UPRN: BJ12002B /  
 115785 / QA Approved / Paul Doodson

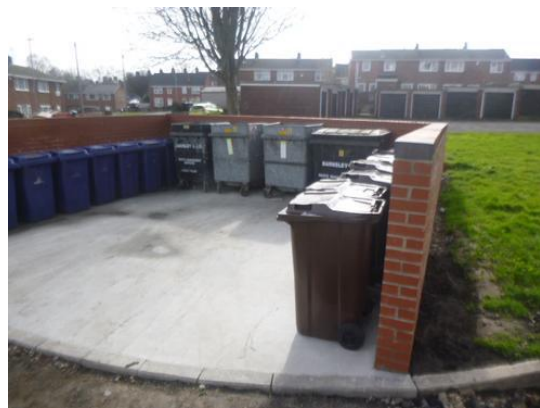
Photo 4

**Are bins secured or fire loading stored in a suitable location? (Please state bin type, location, if and how it is secured)**

The bin chute was still available within the ground floor corridor and not separated by compartmentation. The image shown is the new bin location.

The bin chute is located along the ground floor corridor and any fire would place relevant persons at risk of harm. Remove the bin chute on the ground floor as per floors one to six and inform residents that they should take their rubbish to the new bin compound outside the property.

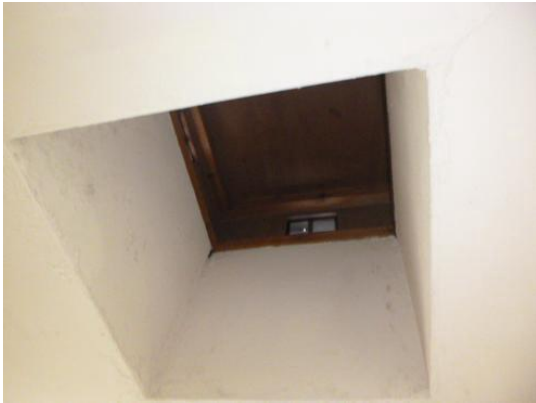
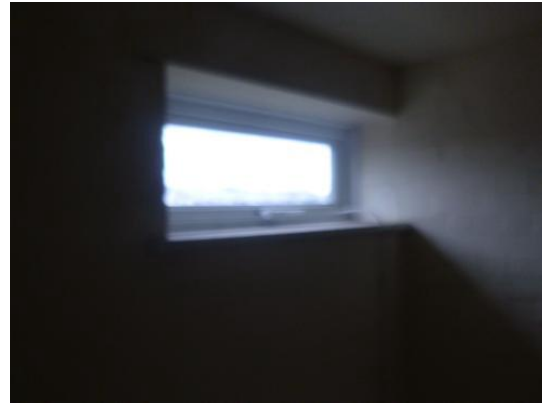
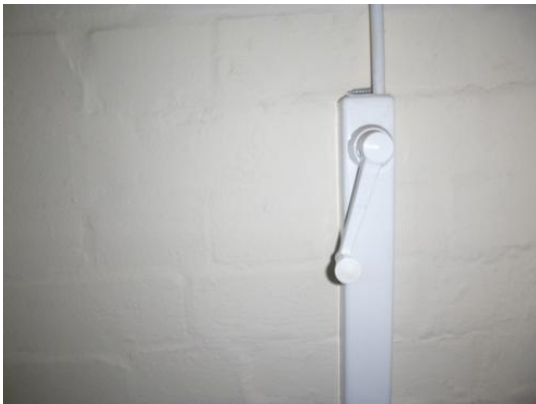
**Are the stairs and/or lobbies provided with adequate ventilation? (If considered satisfactory, please state provision)**

The ventilation at the head of the staircases had been enclosed and any smoke in this area would not be able to naturally vent as the small ventilation bricks were not suitable and this can place relevant persons at risk of harm.

The permanent ventilation at the head of the staircase was enclosed and smoke from any fire could not escape placing relevant persons at risk of harm. Undertake a survey to ensure that there is adequate free space of 1 metre squared of ventilation within the staircases.

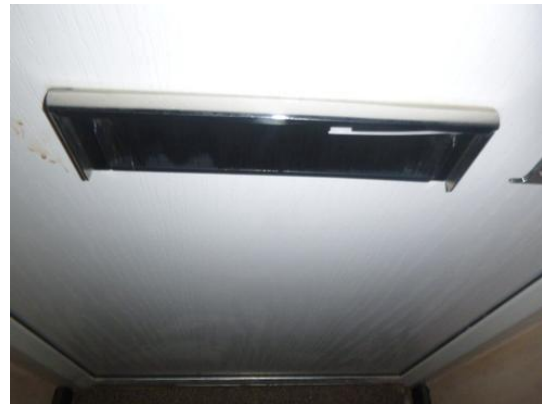
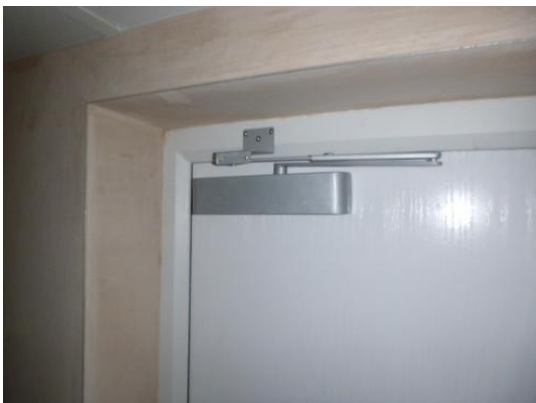
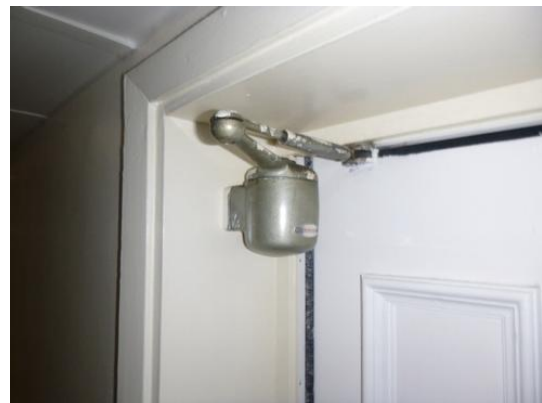
**Are the sample inspection flat entrance door or doors in good condition and appropriately fire rated?**

The flat accessed had an FD30s fire door with a self-closing device and intumescent strips and cold smoke seals fitted. Some of the flats had their original notional 30-minute fire doors with self-closing devices observed and the majority of the flats had new FD30s doors and frames fitted. Flat 1 was missing the letterbox cover and this is part of the furniture and any fire in the flat could pass through the letterbox and allow smoke to enter the common areas placing relevant persons at risk of harm.

Flat 1 had a damaged letter box cover. Replace the damaged letter box cover to the flat door. Work should be carried out by a third party accredited fire door company.

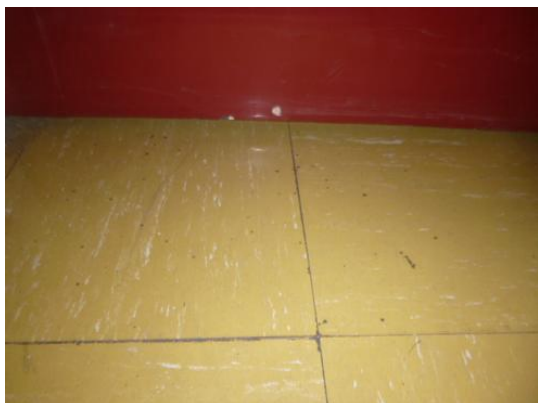
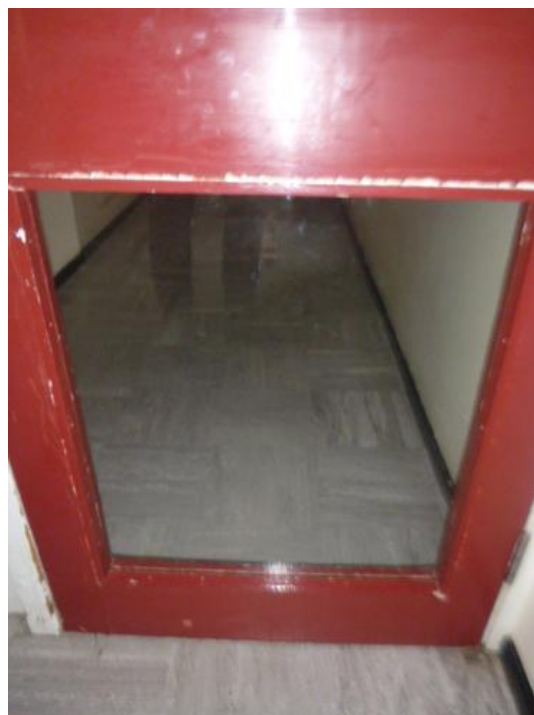
**Are all common area fire door and frames in good condition and appropriately fire rated?**

All the common area doors were secure. Although there were a small number of doors that had excessive threshold gaps at the base to the latch side of the doors, this was due to the flooring being slightly uneven and changes to the door would restrict the door from closing effectively. One door had non-fire-rated glazing fitted and any fire in this area could pass through the glass placing relevant persons at risk of harm.

As part of the fire door checks, ensure that these door thresholds are repaired or replaced when

their gaps are over 8mm at the base of the doors. Replace the non-fire-rated glazing with 30-minute REI glass. Work to be carried out by a third party accredited fire door company.

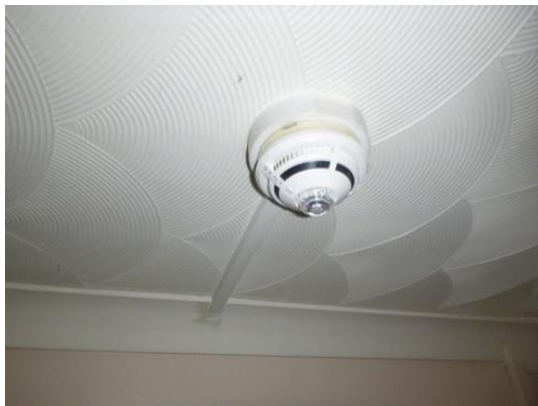
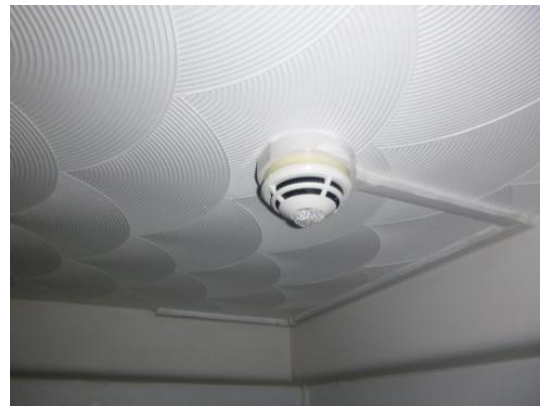
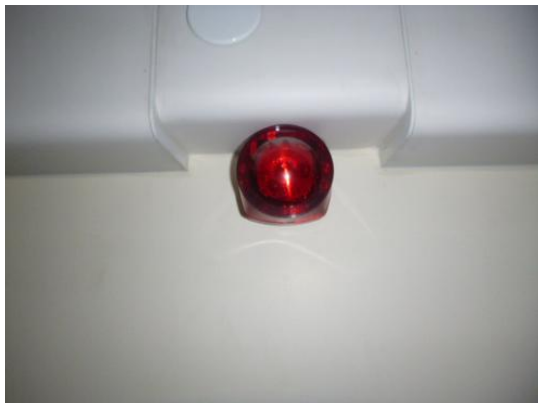
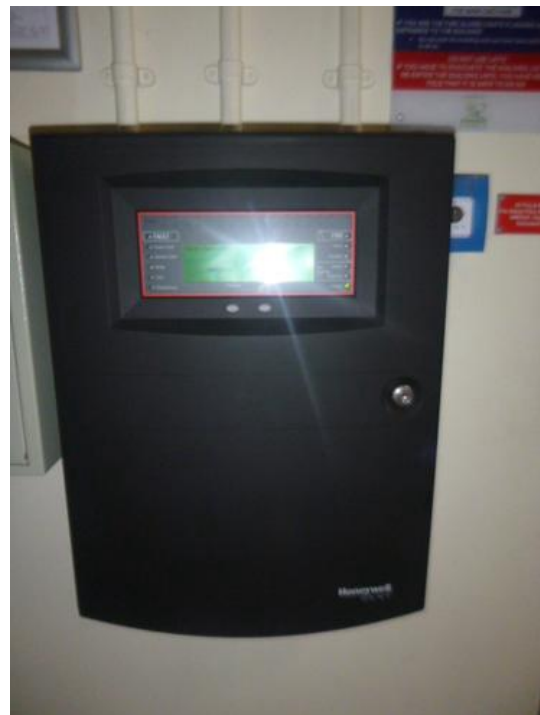
**Is a reasonable fire detection and fire alarm system provided in the common areas, where necessary?**

A common fire alarm to BS 5839 part 1 L2 standard incorporating automatic fire detection is installed within the common areas and the flats. With the exception of the issues identified within this Fire Risk Assessment, it was not identified that there are any serious breaches in the fire compartmentation where a common fire alarm would be a benefit as a compensatory feature. When the findings of this Fire Risk Assessment are remedied, the most appropriate fire strategy for these premises would be a stay-put policy and a communal fire alarm system conflicts with this principle. Purpose-built blocks of flats are not required or do not benefit from common fire detection.

A common alarm was fitted within the common areas. Where the fire resistance meets with the benchmark standards (property compartmented in line with the building regulations 1991) and every flat entrance door is self-closing the common fire alarm system should be removed/disabled providing there are no doubts about the level of compartmentation between the flats and the common area.

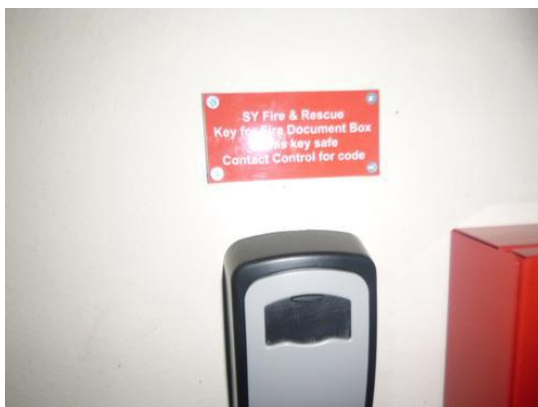
Photo 41

**Is a Premises Information Box located at the premises accessible to the Fire and Rescue Service, secure from unauthorised access and kept up to date?**

No premises information box was observed. The Fire Safety (England) Regulations 2022 made it a legal requirement from 23 January 2023 for existing high-rise residential buildings in England to have a secure information box installed on the premises.

There was no Secure Information Box fitted as per the new requirements from the Fire Safety (England) Regulations 2022. If the red fire safety box is not the premises information box, ensure

that one is fitted.
